Case Study: Squirrels Cause Unexpected Downtime for Data Center

Squirrels led to cable maintenance testing of 15kv cables for a data center.

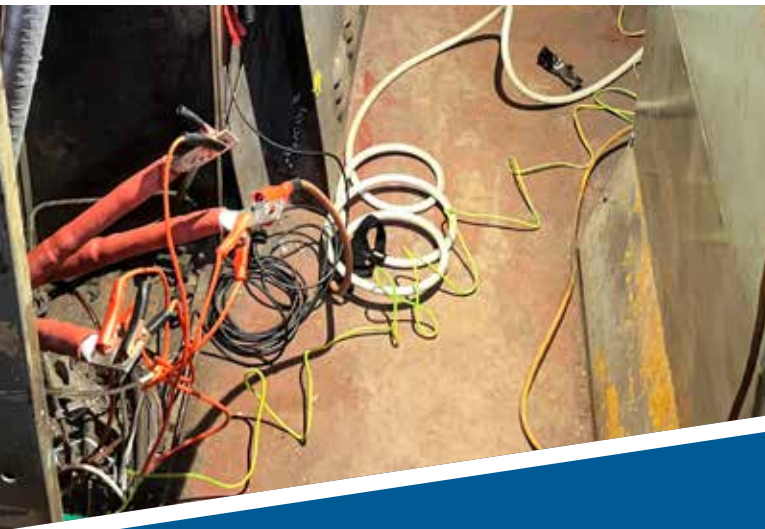
A visual inspection revealed clear disintegration of the terminations, likely due to a squirrel infestation. The B and C phases of the cable terminations had one-quarter of their width remaining and could snap at any moment while under voltage. The technicians determined that a VLF withstand test and Tan Delta testing were necessary to determine the integrity of the 15kV cable.

In this case, the 15kV cable's insulation was intact. A Tan Delta test revealed terminations that started to show signs of failure at half the required voltage capacity of the cables and needed to be replaced immediately.

Following the repair, technicians ran the tests again to ensure the terminations were installed correctly and the cable could withstand the necessary load according to the NETA MTS 2023 standard for 15kV cables. The customer was provided with a detailed report containing our test results and repair details, and we advised the customer that Medium Voltage Cable Testing is recommended every 36 months according to NETA MTS-2023.
